Type of incident: cutting of a 15 kV electrical cable

**Summary:**

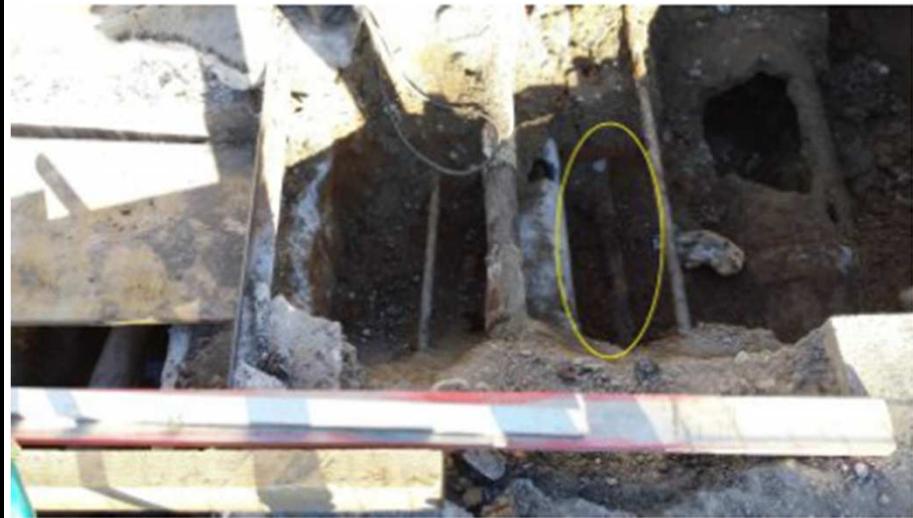
During the partitioning of underground sewers, an alleged disused pipe that interfered was cut with an isolated tool; the Person did not suffer damage, but there was a power failure: inside that conduit there was a live 15 kV electrical cable.

- ✓ Outdated as-built drawing of underground drainage pipeworks;
- ✓ waiver of issue of a work permit.

- ✓ Update as-built drawing of underground drainage pipeworks;
- ✓ retrain People on the use of a work permit system.
